# Manhole Inspection Summary

Manhole # S29UU1020MH

Insp Date: **10/14/08 2:36 PM**

**Location** Address: **5009 BLYTHEWOOD RD**

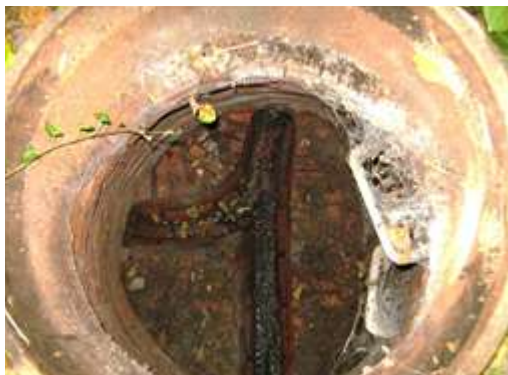
Top View

Frame offset. Evidence of surcharge - Bench debris.

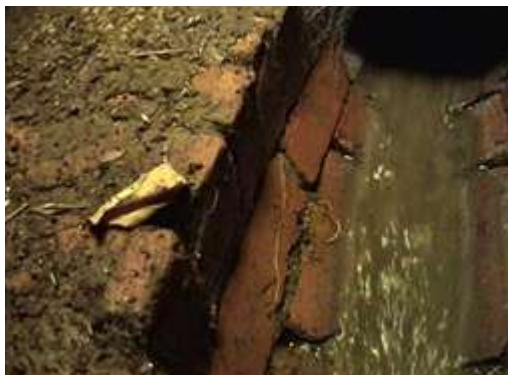
Defect

Condition: ☐ Sound ☐ Cracked ☒ **Root Intrusion** ☒ **Deteriorated** ☐ Leaks ☐ Debris

Channel root intrusion.

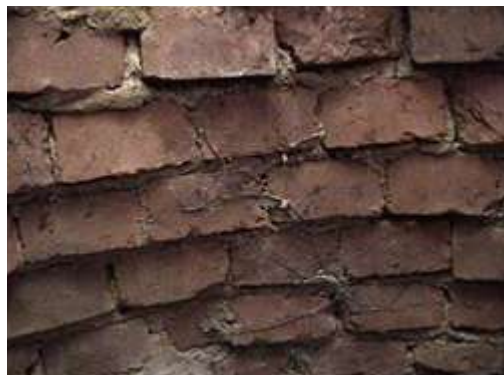
Defect

Condition: ☐ Sound ☐ Cracked ☒ **Root Intrusion** ☐ Loose Brick ☐ Deteriorated

Infiltration: ☐ None ☒ **Joint** ☐ Cracks ☒ **Mortar** ☒ **Roots** ☐ Wall

Corbel root intrusion and infiltration.

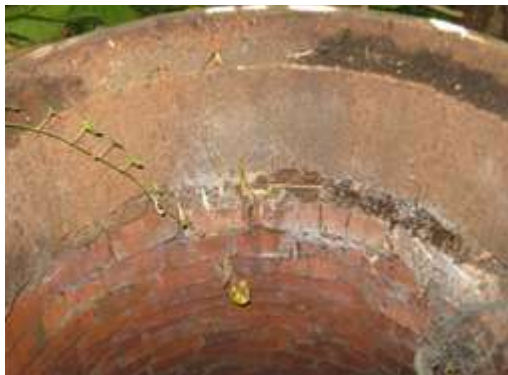
### Defect

Corbel root intrusion and infiltration.

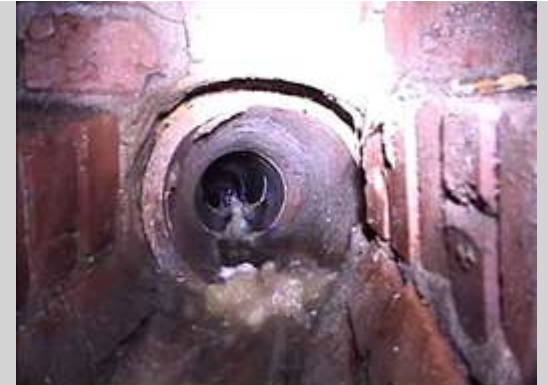
### 8 in. Circular Gravity Sewer Pipe Out @ 12 O'Clock

Channel deterioration.

Infiltration: **Evidence** Pipe Seal Cond: **Roots**

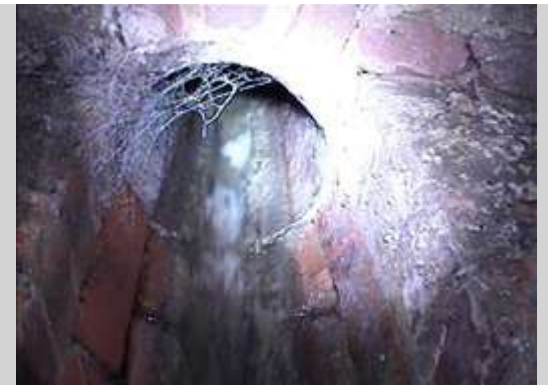
### 8 in. Circular Gravity Sewer Pipe In @ 6 O'Clock

Infiltration: **Evidence** Pipe Seal Cond: **Unknown**

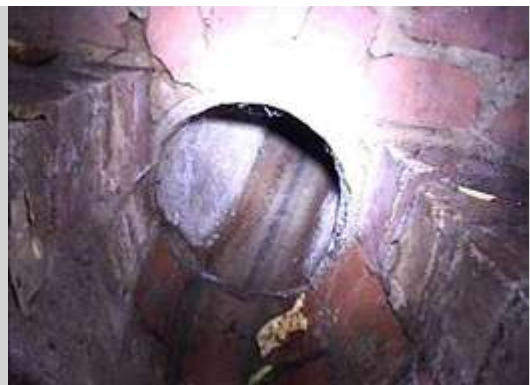
8 in. Circular Gravity Sewer

Pipe Seal Cond: **Cracked**
